Phase I Environmental Site Assessment

Former Hillcrest Golf Course
McKnight Road North and Larpenteur Avenue East
St. Paul, Minnesota

Saint Paul Port Authority

Project B1903316
June 10, 2019

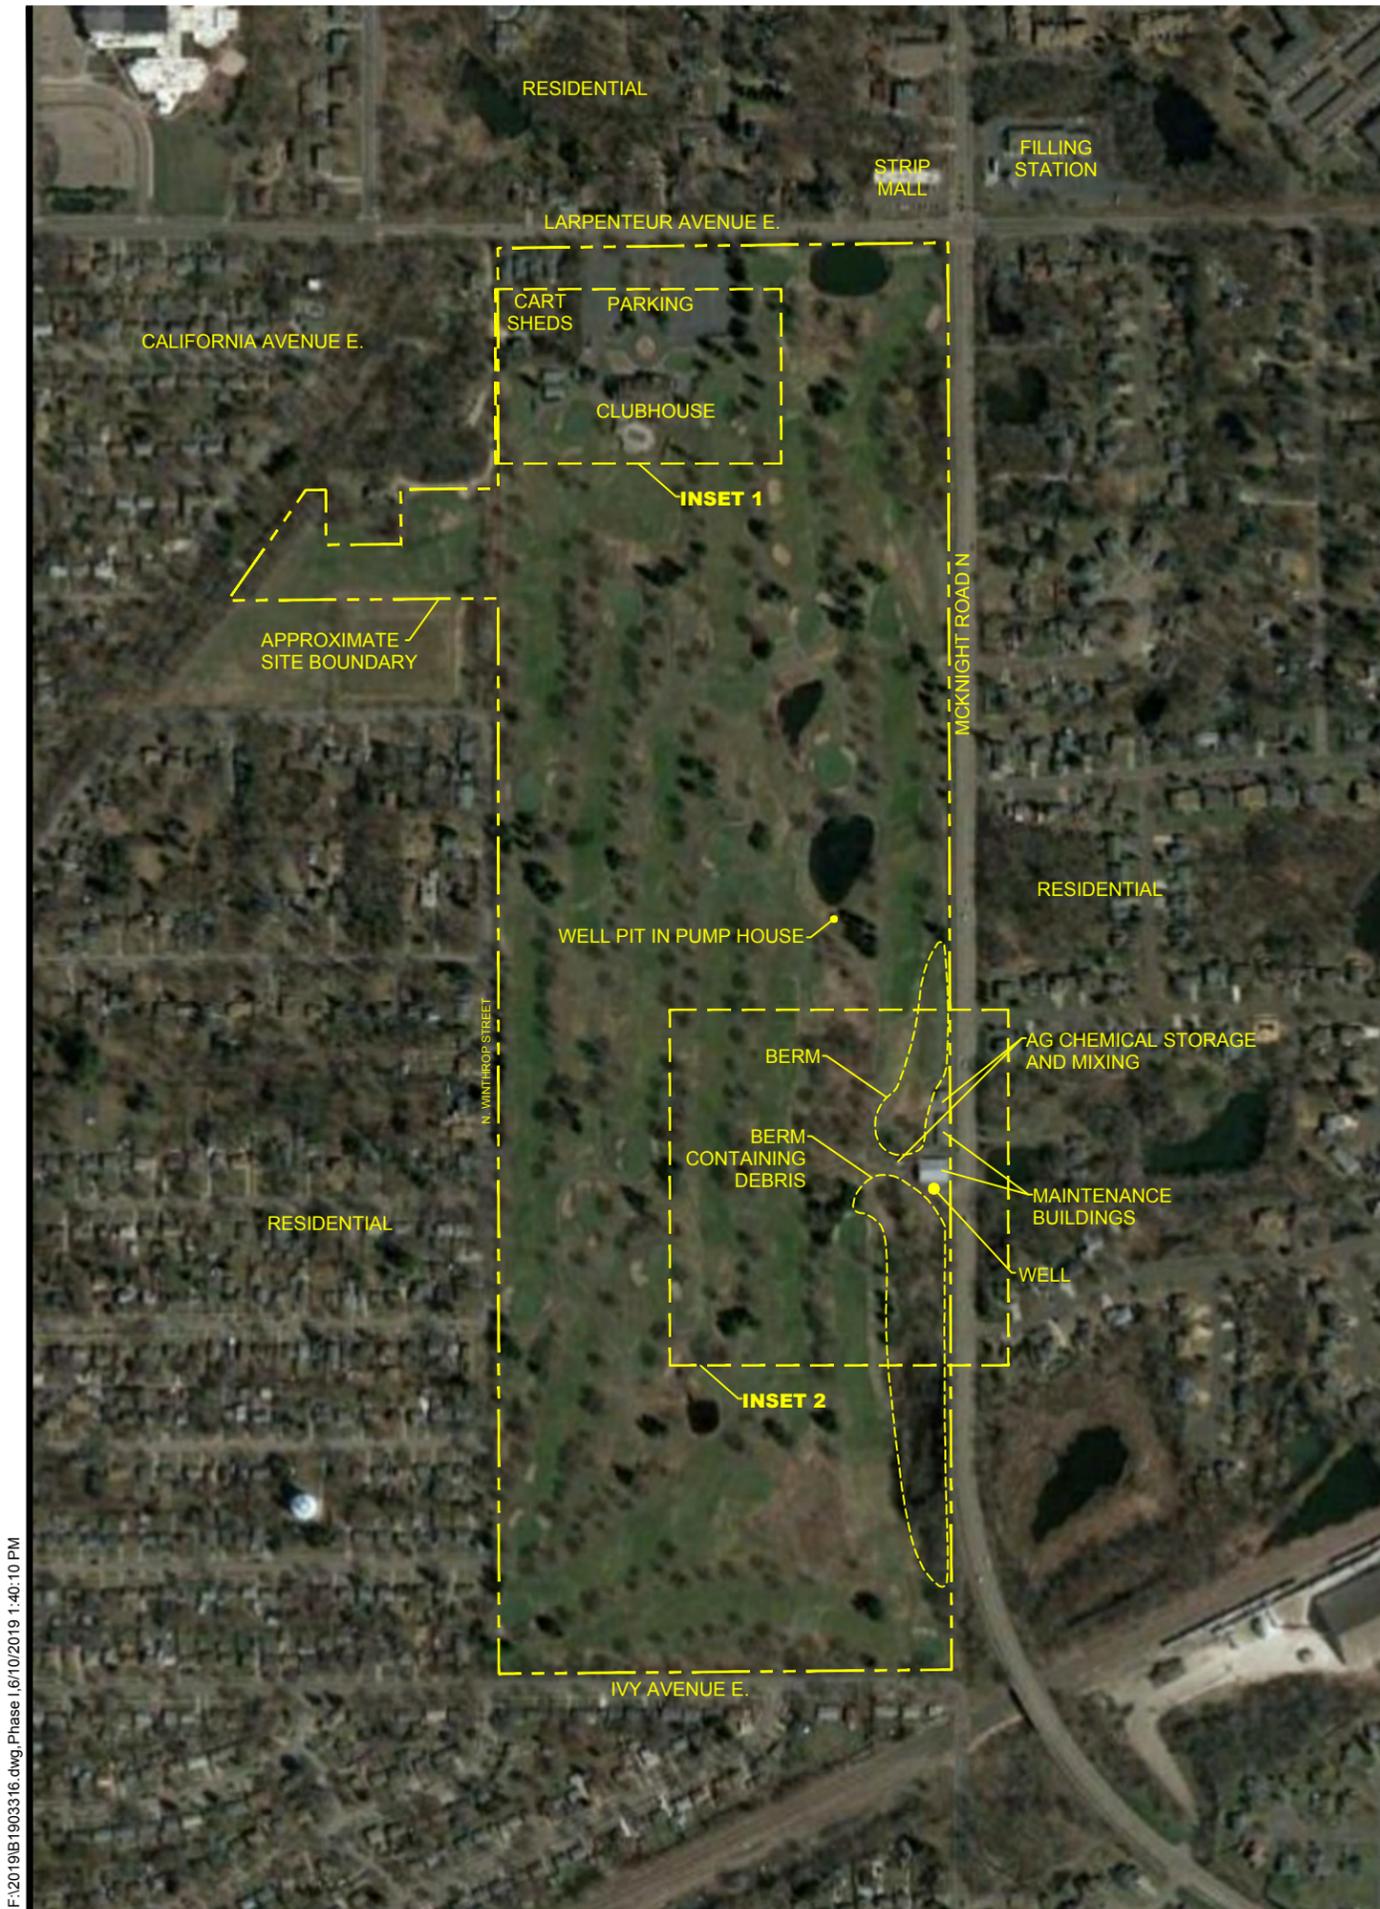
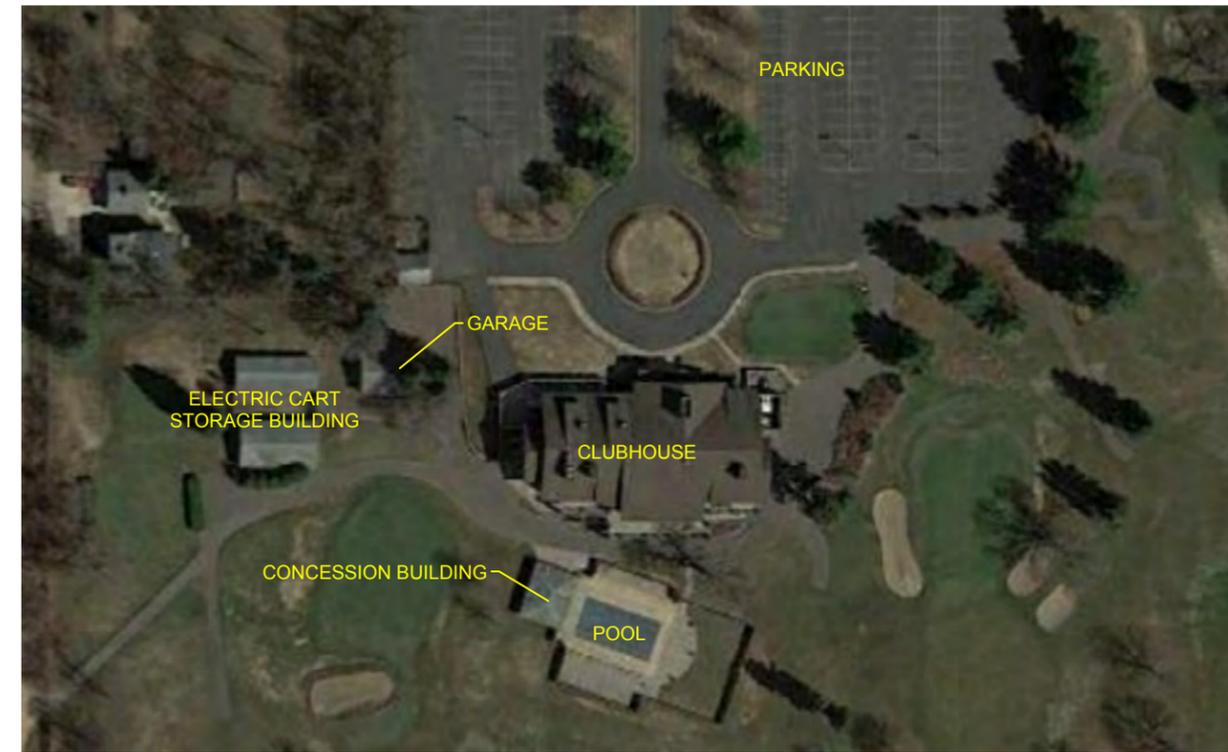
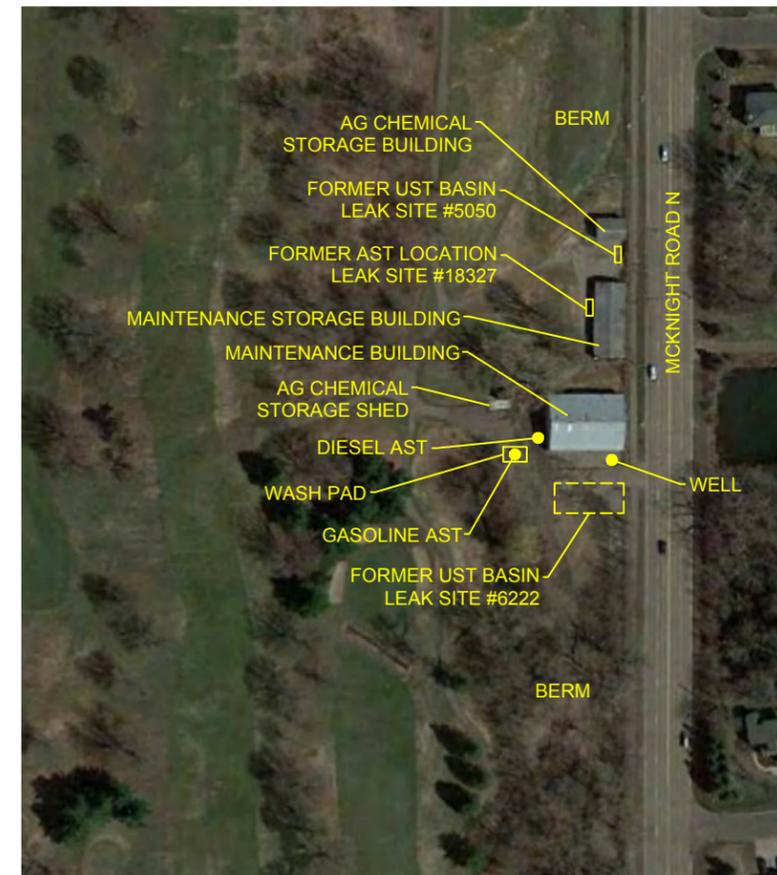
Site Sketch

INSET 1: CLUBHOUSE AREA
SCALE: 1" = 120'

INSET 2: MAINTENANCE FACILITY
SCALE: 1" = 200'

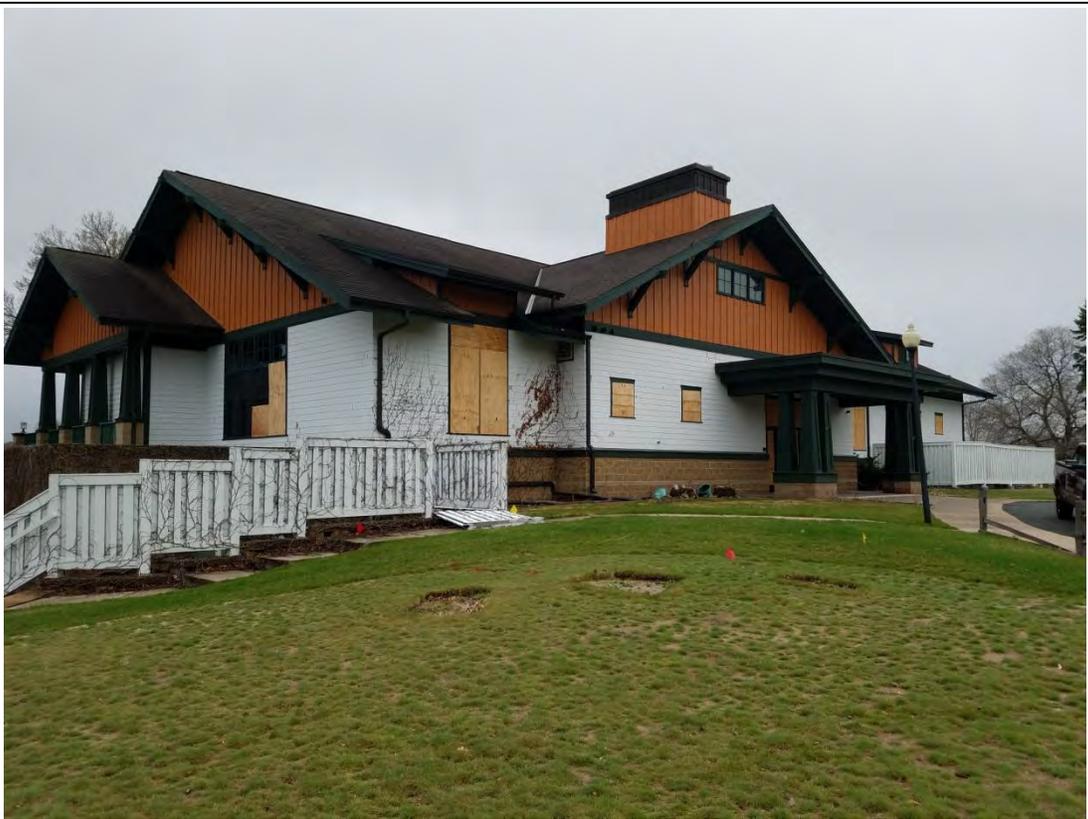
Photograph #1	Hillcrest Golf Club	B1903316
Date:	April 18, 2019 - May 2, 2019	BRAUN INTERTEC
Location:	North side of the Site.	
Subject:	Clubhouse.

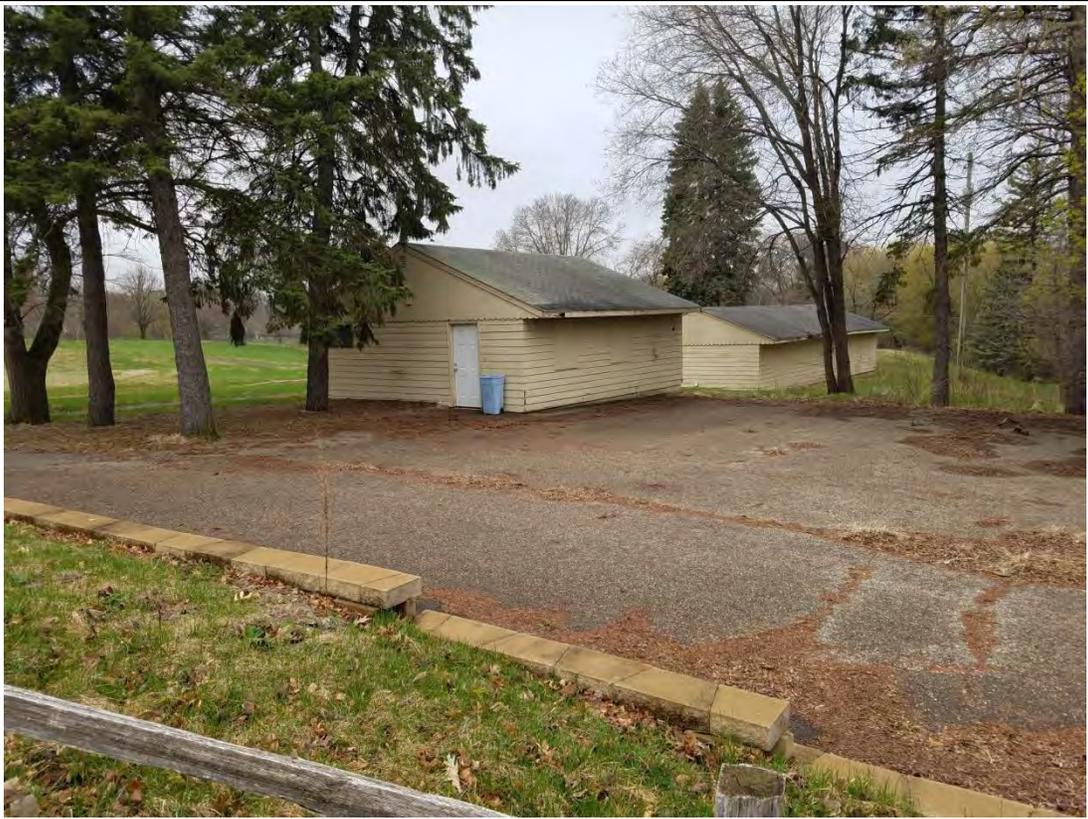
Photograph #2	Hillcrest Golf Club	B1903316
Date:	April 18, 2019 - May 2, 2019	BRAUN INTERTEC
Location:	North side of the Site.	
Subject:	Cart sheds.

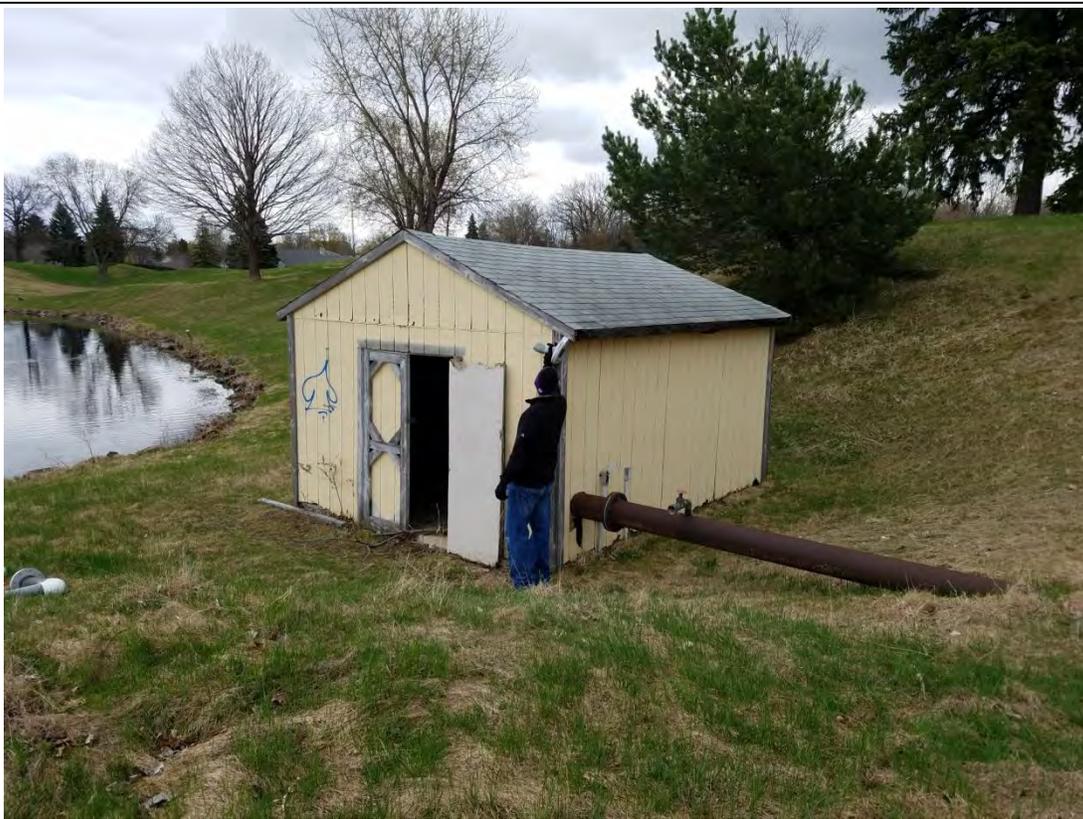
Photograph #3	Hillcrest Golf Club	B1903316
Date:	April 18, 2019 - May 2, 2019	BRAUN INTERTEC
Location:	600 feet north-northwest of maintenance area.	
Subject:	Exterior of Pumphouse. Well pipe entering on right.

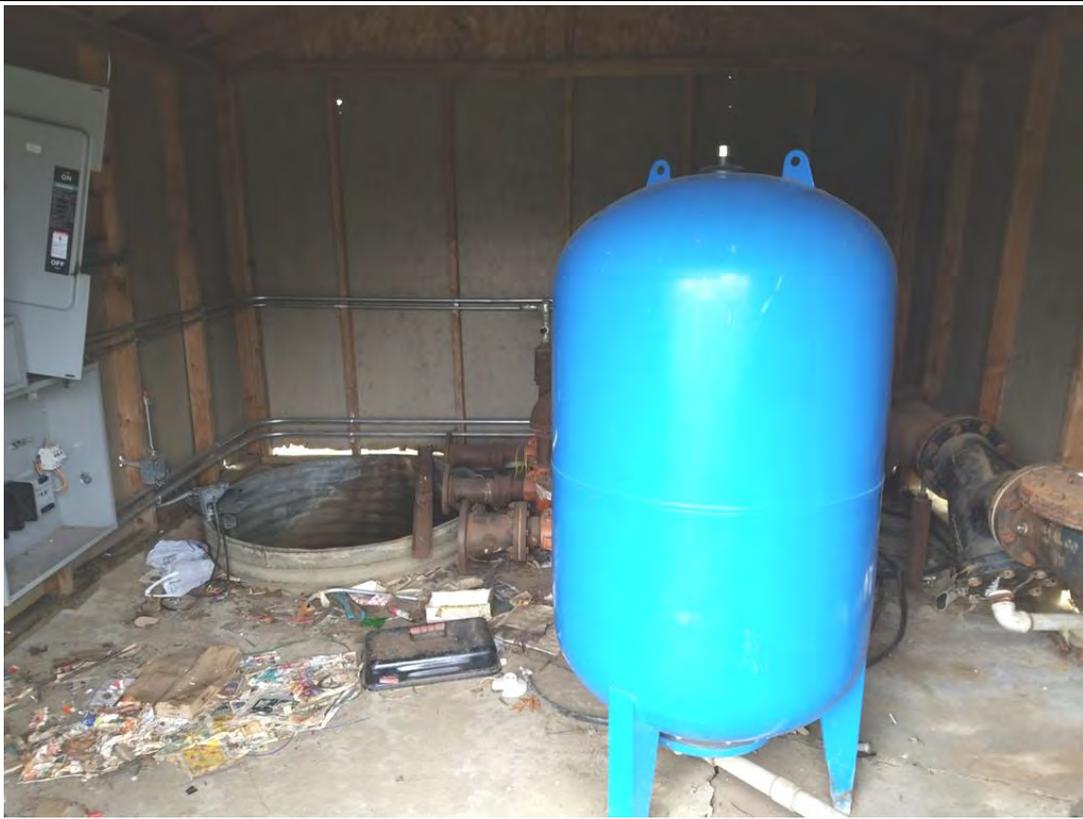
Photograph #4	Hillcrest Golf Club	B1903316
Date:	April 18, 2019 - May 2, 2019	BRAUN INTERTEC
Location:	Interior of pump house	
Subject:	Sump pit to hold water for pumping.

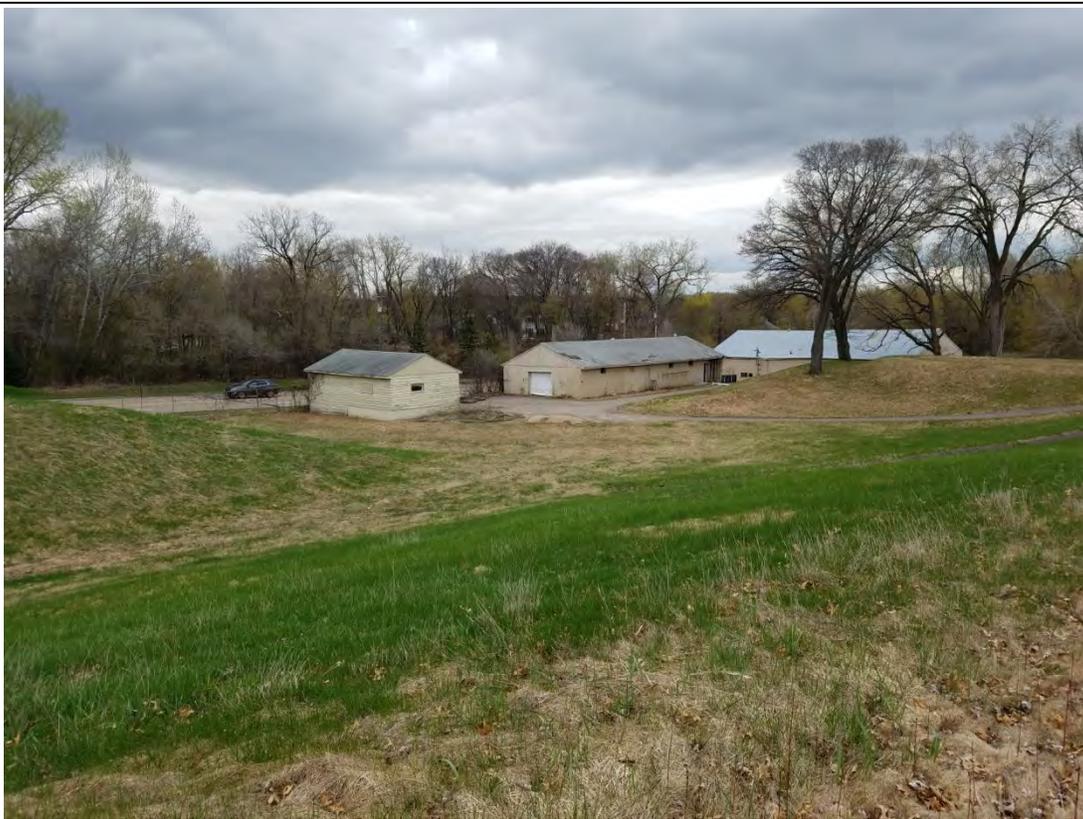
Photograph #5	Hillcrest Golf Club	B1903316
Date:	April 18, 2019 - May 2, 2019	BRAUN INTERTEC
Location:	Northwest of Maintenance Area facing southeast.	
Subject:	Maintenance Area.

- The materials observed protruding from earthen berms next to and south of the maintenance area appeared to indicate a potential for the presence of buried trash, pavements, landscaping spoils, construction and demolition debris in the berms. Based on observations, there is a potential for encountering contaminated soils and buried regulated waste in the berms, which is considered a recognized environmental condition.

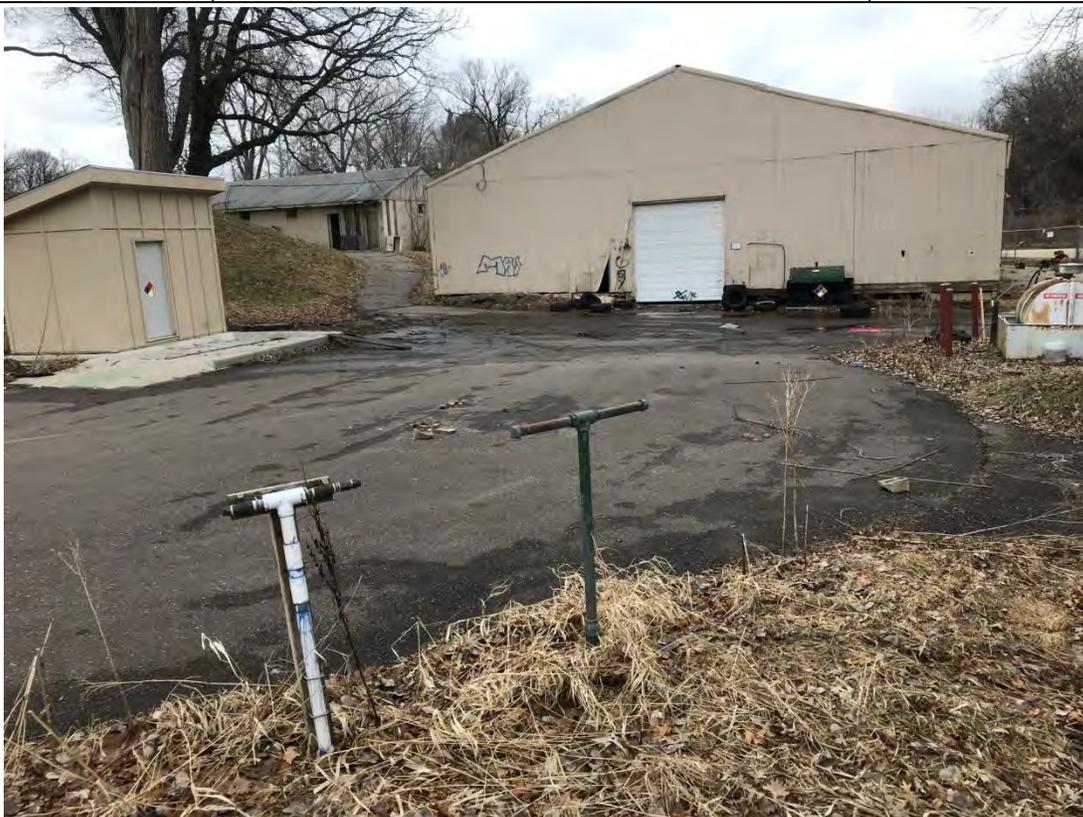
Photograph #6	Hillcrest Golf Club	B1903316
Date:	April 18, 2019 - May 2, 2019	BRAUN INTERTEC
Location:	Maintenance Area/Ag Chem mixing area.	
Subject:	Two ASTs (gasoline and diesel). Water pipe valves.

- Petroleum products including heating oil, gasoline, diesel, stored in aboveground and underground tanks, and lubricant, hydraulic, and others various oils stored in containers ranging in size from one pint to 55-gallons were used on the Site. Government database records and previous investigation reports indicate the likely presence of remaining contamination from past petroleum tank leaks. There is a potential to encounter identified

and unidentified petroleum contamination at the Site during redevelopment, which is considered a recognized environmental condition.

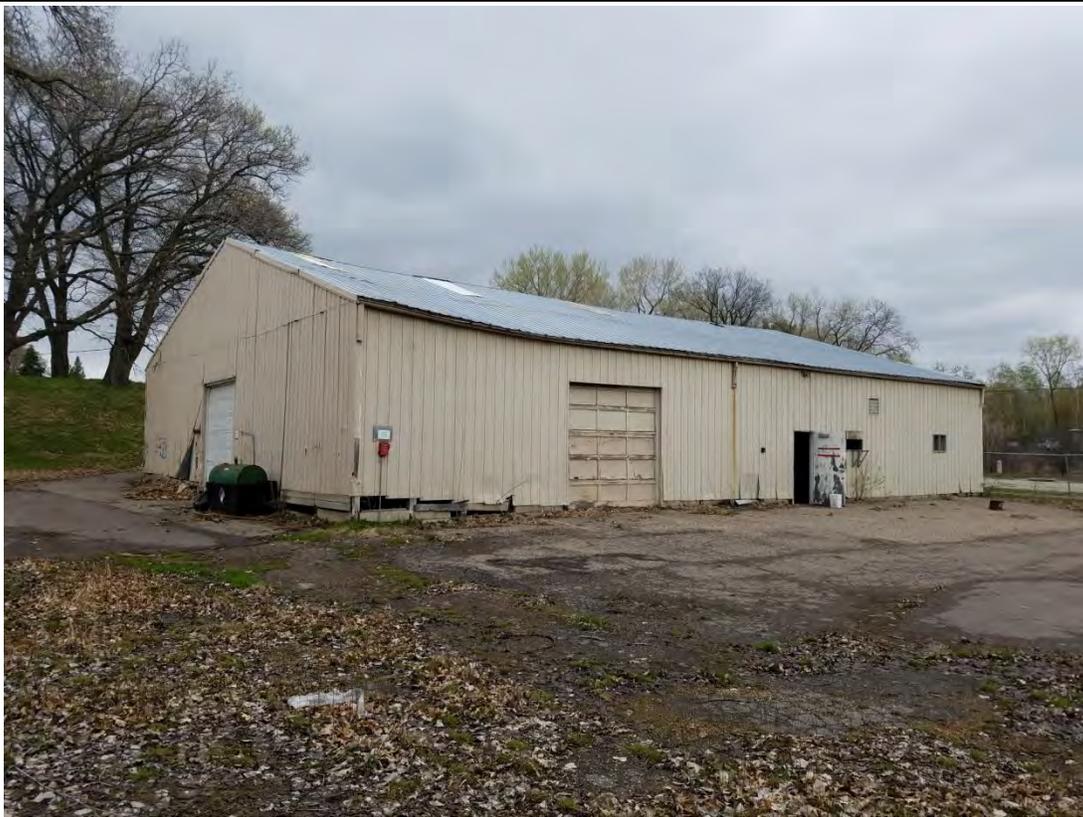
Photograph #7	Hillcrest Golf Club	B1903316
Date:	April 18, 2019 - May 2, 2019	BRAUN INTERTEC
Location:	South side of Maintenance Area.	
Subject:	South side of Maintenance Building. Well on right.

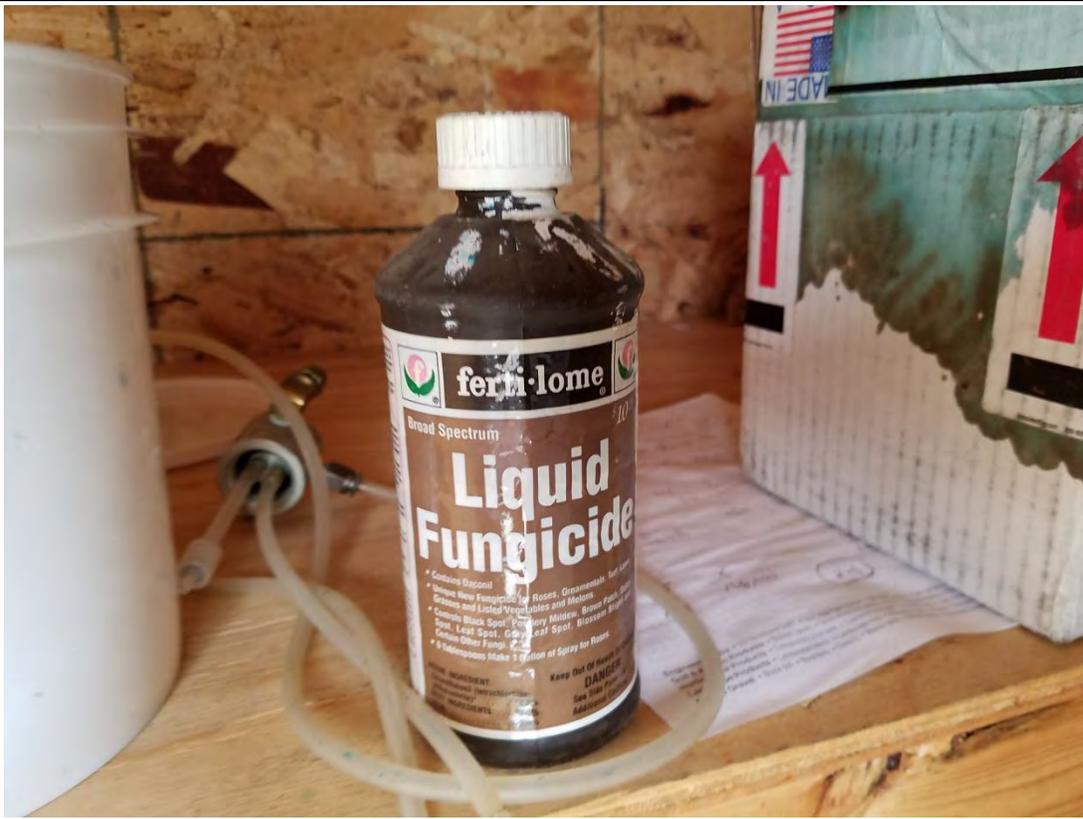
Photograph #8	Hillcrest Golf Club	B1903316
Date:	April 18, 2019 - May 2, 2019	BRAUN INTERTEC
Location:	AG Chem storage.	
Subject:	General conditions.

- The use of the Site included storage, mixing, and application of various agricultural chemicals on the Site. Small quantities of chemicals were still stored on the Site at the time of this reconnaissance. There is a potential for agricultural chemical releases to the soil and groundwater at the Site from spills during mixing, transport, or storage, which is considered a recognized environmental condition.

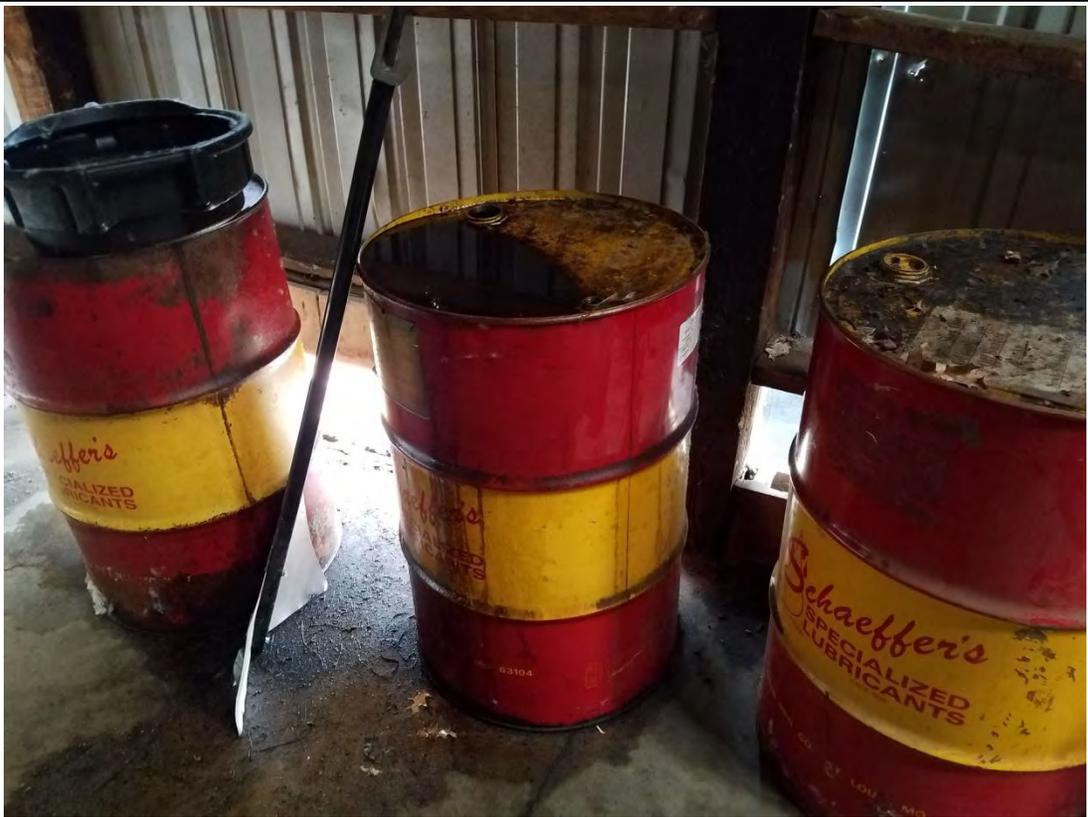
Photograph #9	Hillcrest Golf Club	B1903316
Date:	April 18, 2019 - May 2, 2019	BRAUN INTERTEC
Location:	Maintenance Building.	
Subject:	Oil drums and oil stains and spillage.

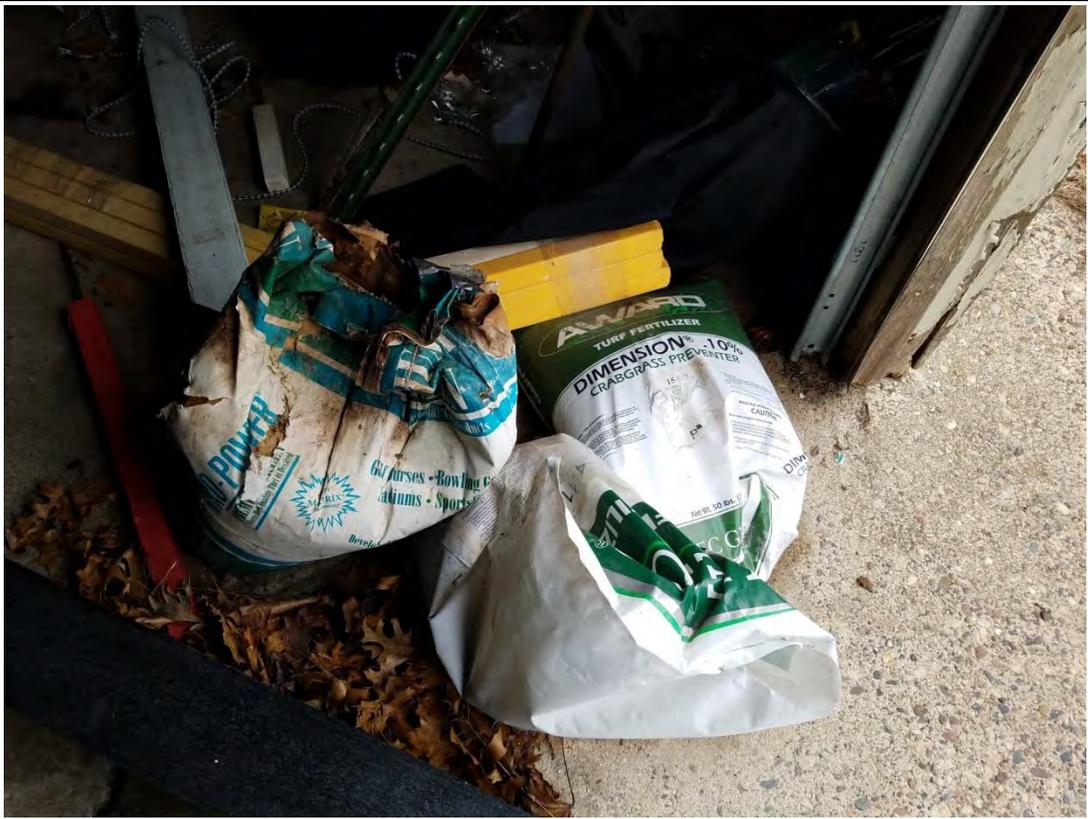
Photograph #10	Hillcrest Golf Club	B1903316
Date:	April 18, 2019 - May 2, 2019	BRAUN INTERTEC
Location:	AG Chem storage.	
Subject:	General conditions.

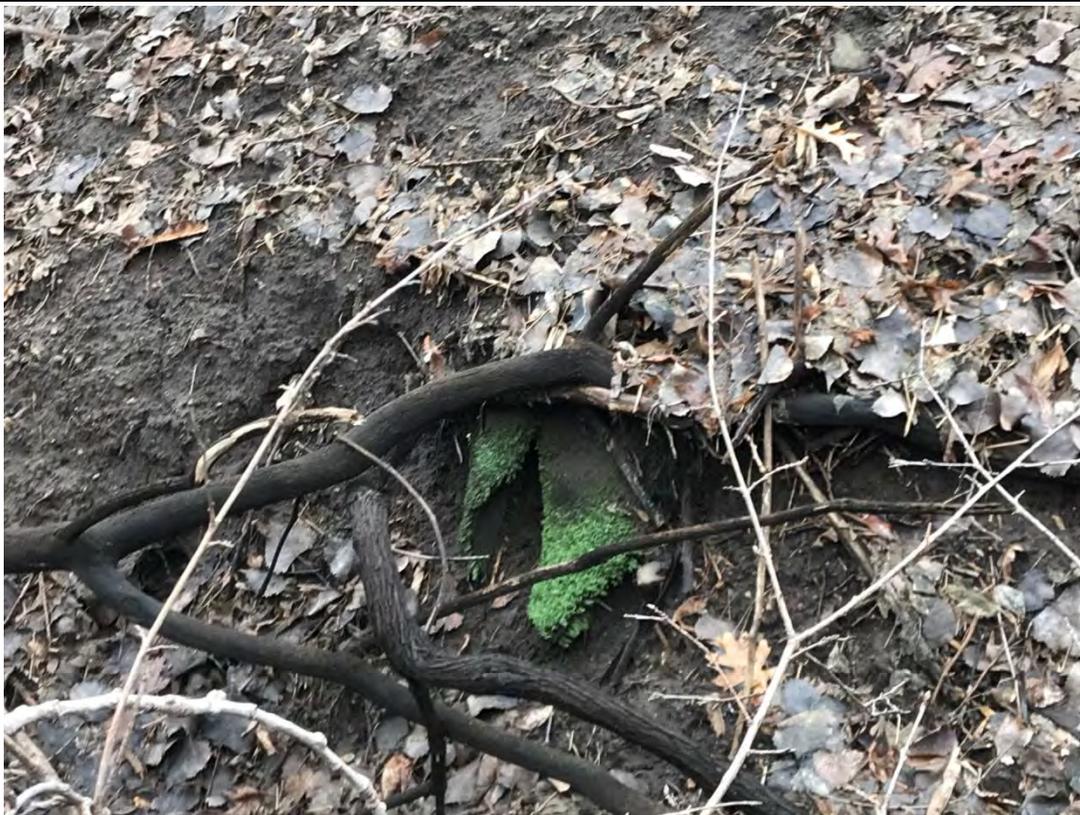
Photograph #11	Hillcrest Golf Club	B1903316
Date:	April 18, 2019 - May 2, 2019	BRAUN INTERTEC
Location:	Berms south of Maintenance Area.	
Subject:	Artificial Turf protruding from berm. T

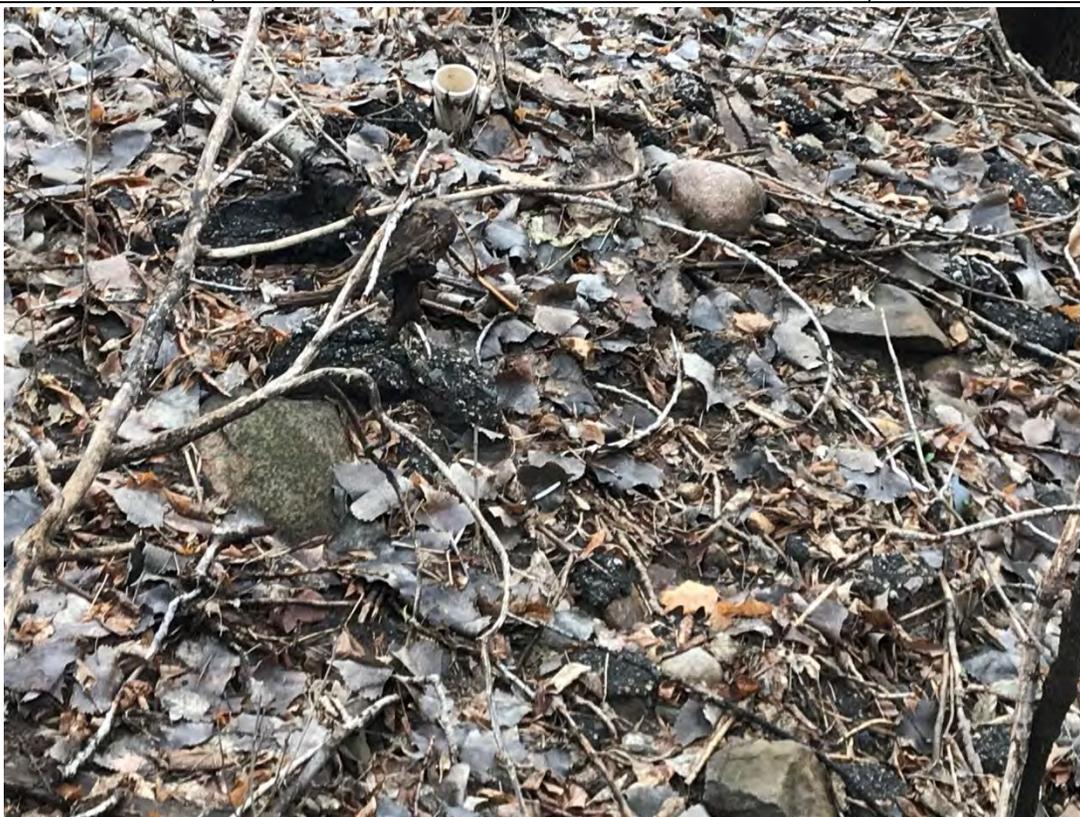
Photograph #12	Hillcrest Golf Club	B1903316
Date:	April 18, 2019 - May 2, 2019	BRAUN INTERTEC
Location:	Berms south of Maintenance Area.	
Subject:	Asphalt, concrete, and PVC pipe in berm. T

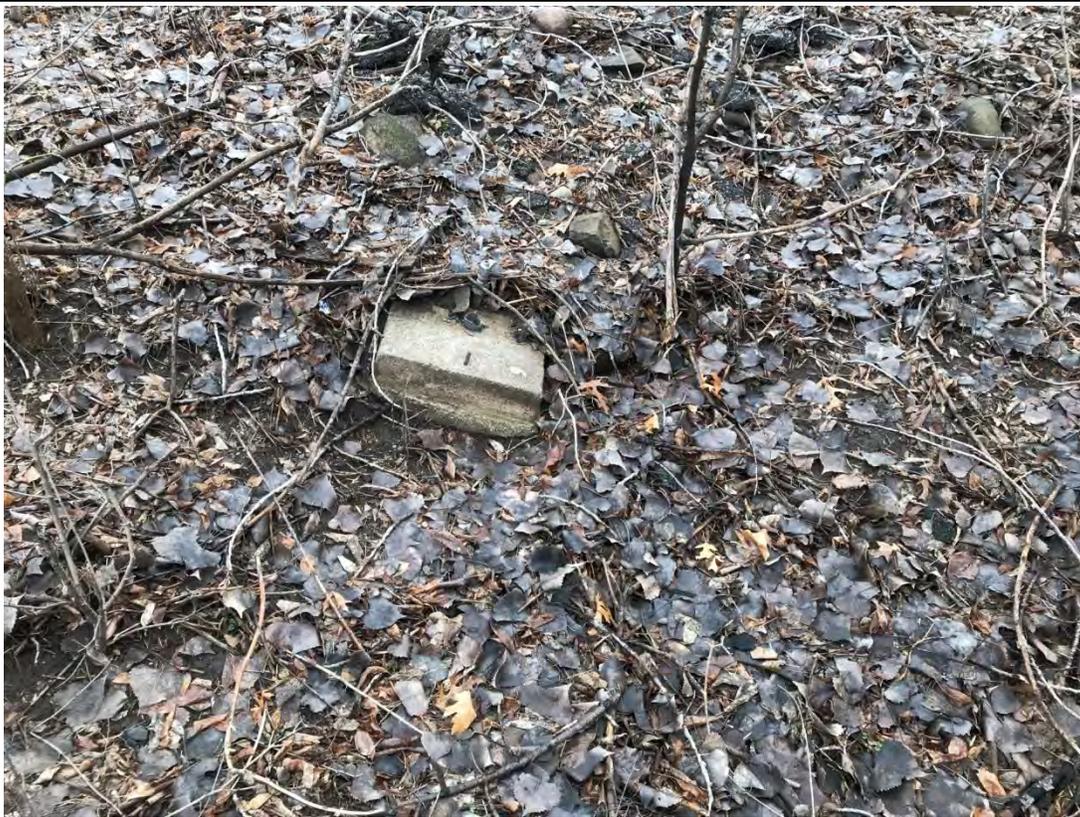
Photograph #13	Hillcrest Golf Club	B1903316
Date:	April 18, 2019 - May 2, 2019	BRAUN INTERTEC
Location:	Berms south of Maintenance Area.	
Subject:	Concrete and pipe protruding from berm. T

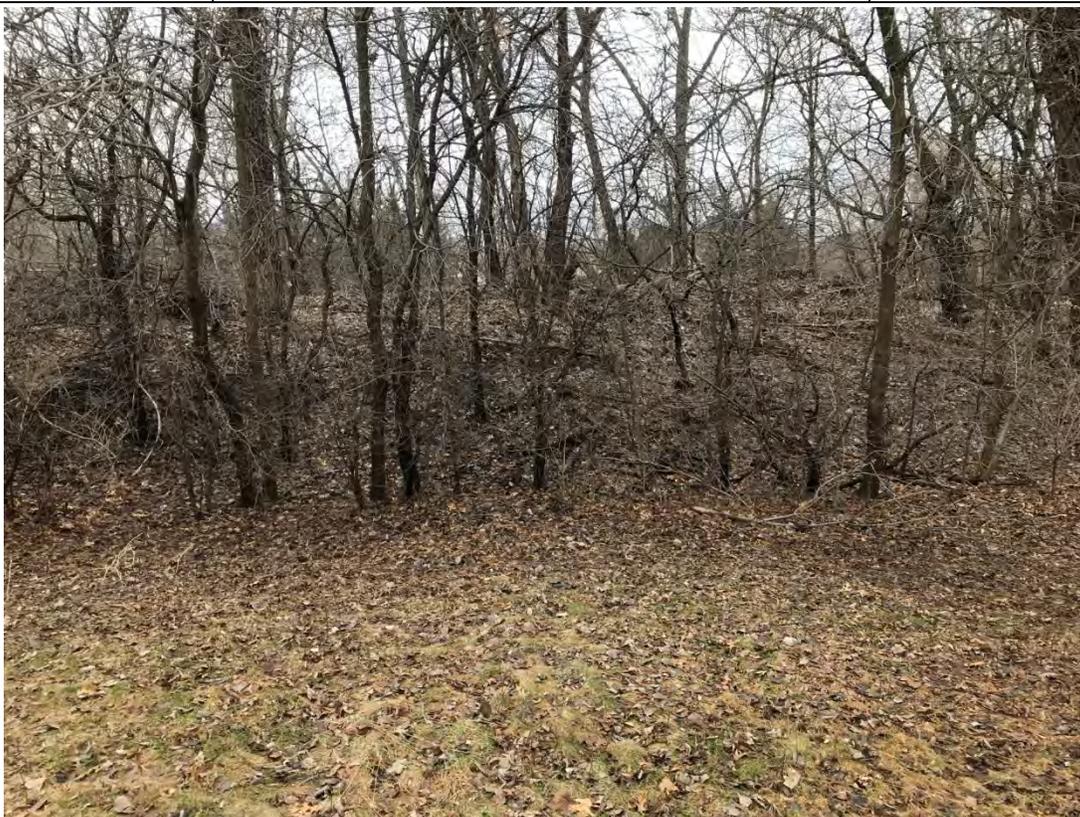
Photograph #14	Hillcrest Golf Club	B1903316
Date:	April 18, 2019 - May 2, 2019	BRAUN INTERTEC
Location:	Berms south of Maintenance Area.	
Subject:	General view of berm.
