# **Revised Response Action Plan**

Hillcrest Redevelopment Site Saint Paul, Minnesota MPCA Brownfields Site ID: BF0001281 MDA Project No.: JAL101091523

# **Saint Paul Port Authority**

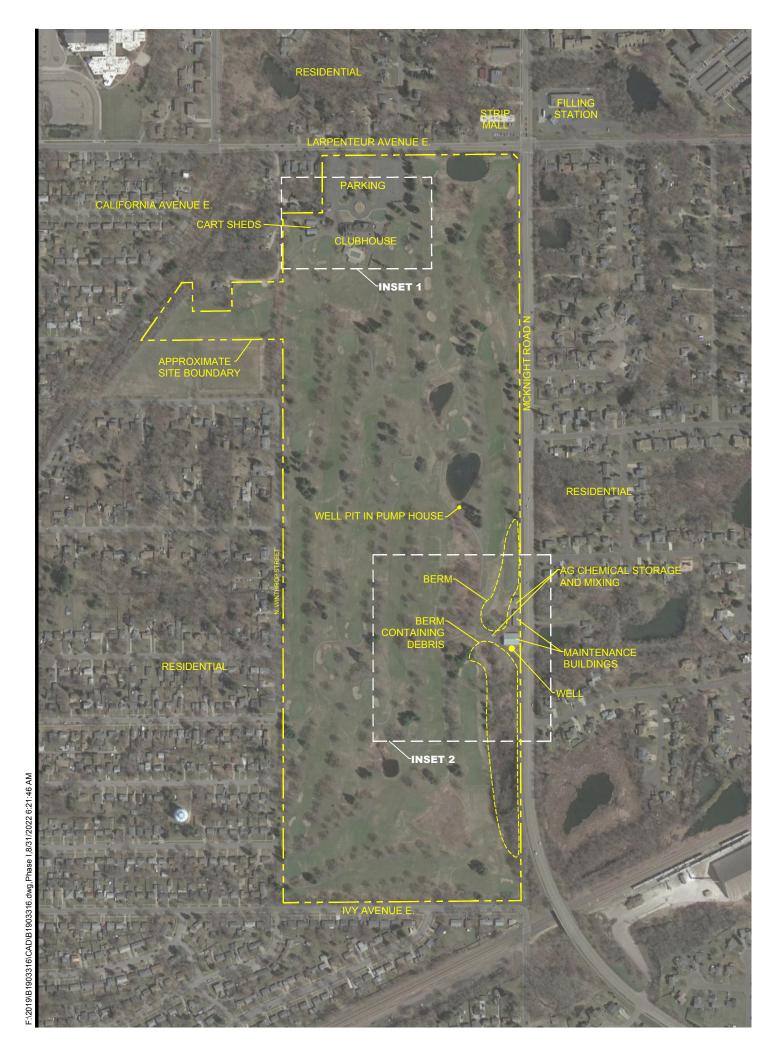
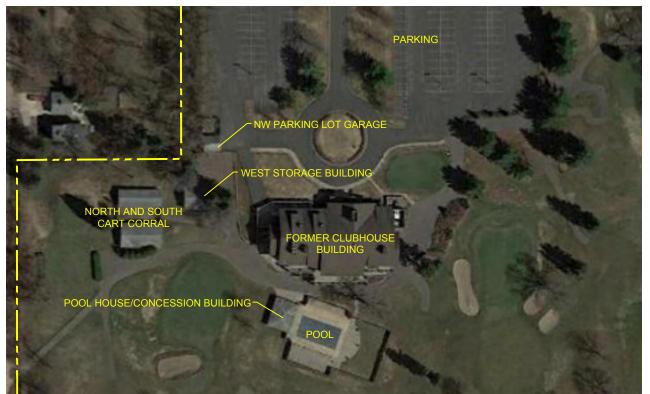
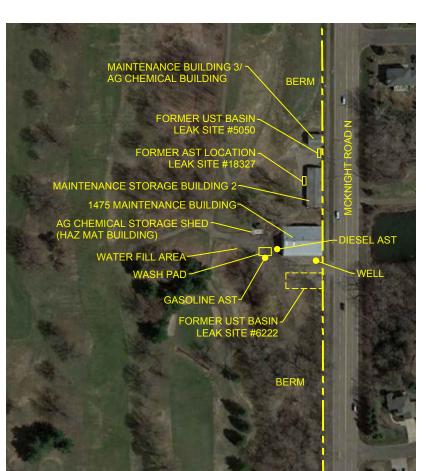
Figure 2

INSET 1: CLUBHOUSE AREA SCALE: 1" = 120'

INSET 2: MAINTENANCE FACILITY
SCALE: 1" = 200'

**Current Site Conditions**

The Site was developed and used as a golf course from the early 1920s until golf course operations ceased in 2017. The Site is currently occupied by the former golf course operations structures, including unmaintained greens, tee boxes, and fairways, a driving range, practice putting greens, and support buildings. A vacant clubhouse with associated paved parking lot, swimming pool, vacant pool building, vacant golf cart sheds, and vacant garages are in the northwest corner of the Site. There was an original clubhouse that was severely damaged by fire in 1962. The remains of the destroyed clubhouse were demolished and replaced with a new clubhouse that was subsequently demolished between 1994 and 2000 and replaced by the current existing vacant clubhouse in 2000. The former fairways extended south of the club house. A vacant maintenance area located in the southeastern portion of the Site includes a former maintenance shop building, former maintenance storage building, and former agricultural chemical storage and mixing buildings (agricultural chemical buildings). Earthen berms containing various fill soils with debris are located along the southeastern Site boundary next to and south of the former maintenance area. Two out of service (the pumps were removed in 2020) unsealed water wells are present at the Site, including three shallow monitoring wells installed during the 2020 RI and two deeper production wells, an out of service irrigation well located near the center of the site, and an out of service production well located in the maintenance area.

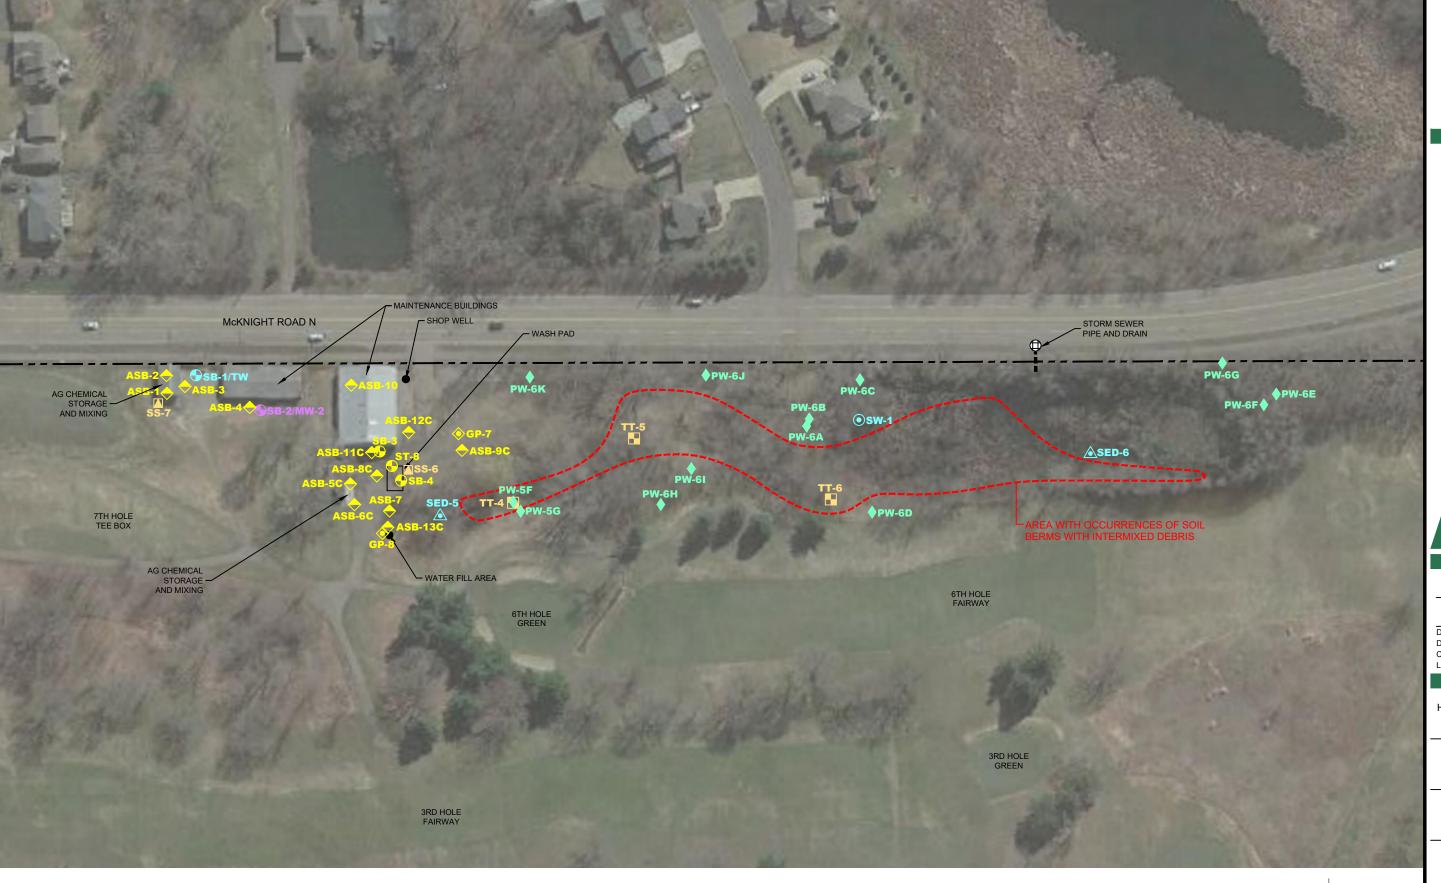
MERCURY CONCENTRATIONS IN SOIL EXCEED SOIL REFERENCE VALUE FOR MECURY

MERCURY CONCENTRATIONS IN SOIL ARE BELOW THE SOIL REFERENCE VALUE FOR MERCURY
