Response Action Plan

Hillcrest Redevelopment Site Saint Paul, Minnesota MPCA Brownfields Site ID: BF0001281 MDA Project No.: JAL101091523

Project B1903316.00 March 1, 2022

Braun Intertec Corporation

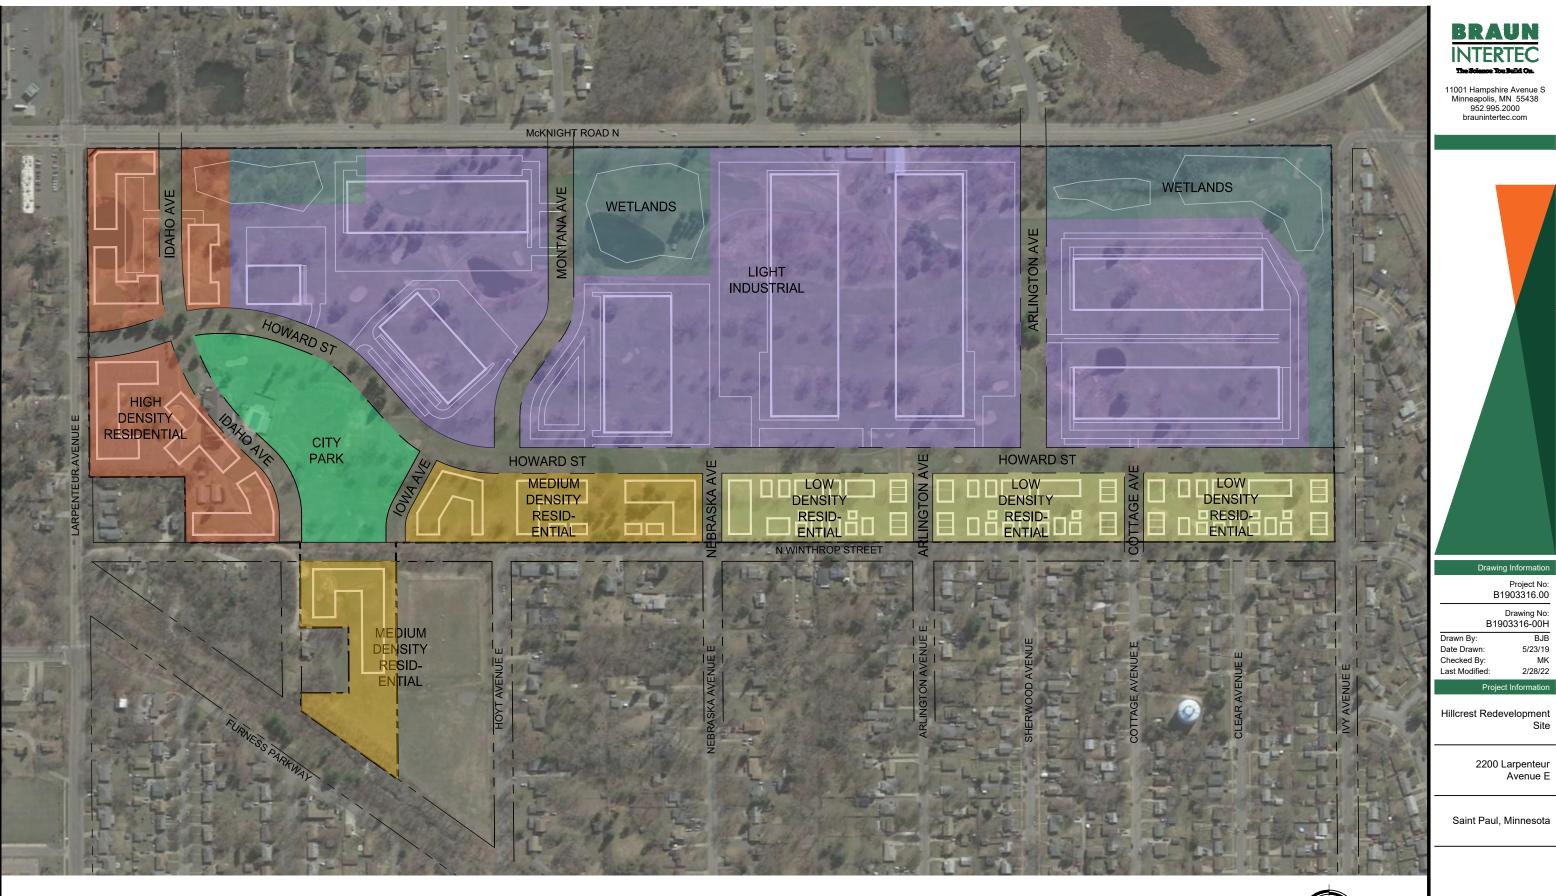
Site Plan

TYPE 2 SOILS ARE RESTRICTED TO REUSE ONSITE ONLY WITHIN THE ROADS, IN THE AREAS ZONED AS WETLANDS, INDUSTRIAL, OR COMMERCIAL USE, AND IN THE AREA ZONED AS CITY PARK, WITH A 1 FOOT CLEAN SOIL BUFFER.
